**Flood Control Project Maintenance  
Levee Inspections**

**Fall 2019 Levee Maintenance Deficiency Summary Report**

<b>RD0349</b>	Overall LMA Rating	Total LMA Miles						
<b>Reclamation District No. 0349 Sutter Island</b>	<b>U</b>	<b>12.41</b>						
Rated Item	Maintenance Deficiency				Enforcement		Design & System Obsolescence	
	M Miles	U Miles	M + 4U Miles	Threshold %	M Miles	U Miles	M Miles	U Miles
<i>Earthen Levee</i>								
Vegetation	5.48	3.84	20.84	167.97%	0.14	0.57		
Trim / Thin Trees	0.26	0.04	0.42	3.39%				
Encroachments	0.24		0.24	1.93%	1.04	0.29		
Animal Control	0.18		0.18	1.45%				
Slope Stability	0.01		0.01	0.08%				
Crown Surface / Depressions / Rutting	0.01		0.01	0.08%				
Flood Preparedness & Training	0.12		0.12	0.97%				
<i>Supplemental</i>								
2017 USACE Erosion Survey	0.35		0.35	2.82%				
DRAFT DWR UCIP Field Study					0.50	0.01		
2017 Storm Damage	0.22		0.22	1.77%				
<i>LMA Totals:</i>	6.87	3.88	22.39	180.46%	1.68	0.87	0.00	0.00

**Flood Control Project Maintenance  
Levee Inspections****LMA District Cover Sheet  
Fall 2019 Levee Inspection Results****Reclamation District No. 0349 Sutter Island**

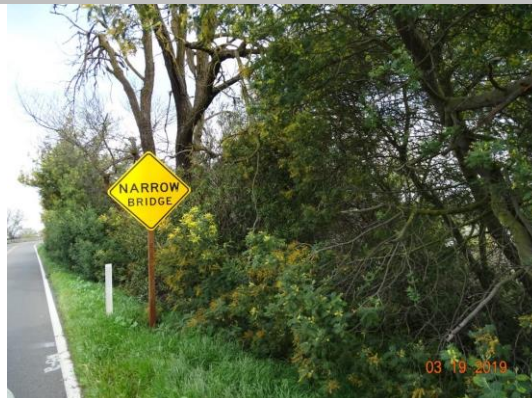
Photo 1 of 1 : FA\_2019\_RD0349\_204\_20\_20190826\_00006.jpg

LM Start	0.01	Rating **	U	Issue No.	20
LM End	0.06	Issue Type +	En	Location *	WS
Category	Earthen Levee			GPS Latitude/Longitude	
				Start	End
Item	Vegetation			38.327167°	38.326340°
				-121.577210°	-121.577023°
DWR ID	DWR_RD0349_01_s_2019_20				
Comment Code					
V6 : Landscaping					
Inspector Comment

View looking upstream at landscape vegetation on the waterside slope (Spring 2019).

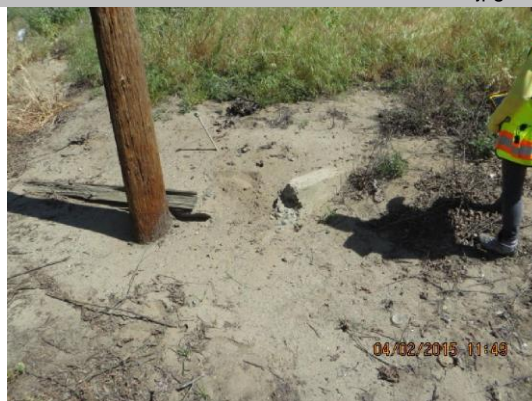
Photo 1 of 3 : UCIP\_FA\_2019\_44303\_73622.jpg

Comment Code						
Inspector Comment						
DS_ID:24137						
FS_ID:44303						
EP_NO: N/A						
Repair Type: Non-Urgent						
Crossing Status: Indicator Found						
UCIP Comments: Pipe appears to be abandoned and if so should be done so properly. Electromagnetic survey indicated a crossing at this location.						
FIELD_STRUCT_DESC: *ABANDONED* 10-inch irrigation pipe of unknown material through the levee, 3.8 feet below the levee crown. Power pole and anchor on the landside (LS). Deteriorated concrete box at the LS toe. Concrete debris on the waterside (WS) toe good indicator of pump location. [Additional Reference(s): DWR Levee Log, 2005. USACE Sacramento O&M Manual Unit No. 110, May 1959, revised 29 Dec 2016, (HLM 0.1)]						
FS Date: 4/2/2015

Deteriorated concrete distribution box on LS toe next to power pole.

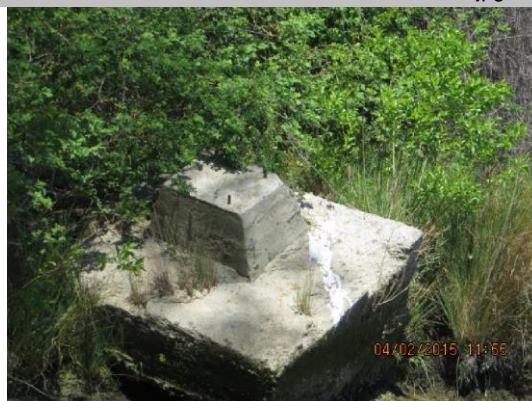
Photo 3 of 3 : UCIP\_FA\_2019\_44303\_73620.jpg

Comment Code						
Inspector Comment						
DS_ID:24137						
FS_ID:44303						
EP_NO: N/A						
Repair Type: Non-Urgent						
Crossing Status: Indicator Found						
UCIP Comments: Pipe appears to be abandoned and if so should be done so properly. Electromagnetic survey indicated a crossing at this location.						
FIELD_STRUCT_DESC: *ABANDONED* 10-inch irrigation pipe of unknown material through the levee, 3.8 feet below the levee crown. Power pole and anchor on the landside (LS). Deteriorated concrete box at the LS toe. Concrete debris on the waterside (WS) toe good indicator of pump location. [Additional Reference(s): DWR Levee Log, 2005. USACE Sacramento O&M Manual Unit No. 110, May 1959, revised 29 Dec 2016, (HLM 0.1)]						
FS Date: 4/2/2015

Concrete debris on WS toe is a good indicator of pump location.

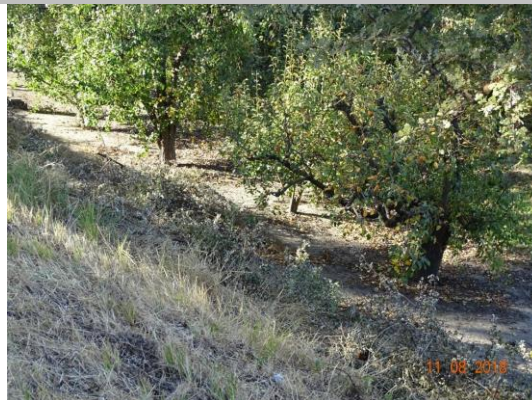
Photo 1 of 1 : FA\_2019\_RD0349\_204\_17\_20190826\_00004.jpg

LM Start	0.14	Rating **	M	Issue No.	17
LM End	0.14	Issue Type +	En	Location *	LS
Category	Earthen Levee			GPS Latitude/Longitude	
				Start	End
Item	Encroachments			38.325248 °	38.325248 °
				-121.577478 °	-121.577478 °
DWR ID	DWR_RD0349_01_f_2018_17				
Comment Code					
CR : Crops					
Inspector Comment					
Orchard trees are encroaching on the landside toe.

View of orchard trees encroaching on the landside toe (November 2018).

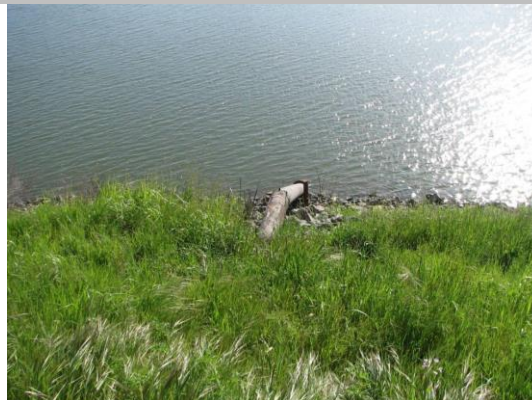
Photo 1 of 3 : UCIP\_FA\_2019\_50062\_36547.jpg

Comment Code					
Inspector Comment					
DS_ID:24139 FS_ID:50062 EP_NO: 951 Repair Type: Non-Urgent Crossing Status: Found UCIP Comments: 8/22/2016 Meet Fred Wheeler with RD349 at this crossing. Crossing is active. Crossing was downgraded from Urgent to Non-Urgent -- no signs of pipe failure visible on surface. Need to contact owner -- dense vegetation on WS and LS should be cleared prior to next inspection. Need to coordinate with owner regarding the 8-inch sleeved pipe--need permit number to update record. (DWR UCIP - omagana)3/18/2009 Exposed section of levee slope on LS--need to contact owner and DWR inspector. Burrow activity noticed at crossing 10 inch holes. Dense vegetation limits the inspector's visibility to identify signs of pipe failure (leaks) along the slope. Recommend removing vegetation along pipe alignment to conduct proper inspection of structure and appurtenances. Note date on photos should be 3/18/09 not 7/26/08 camera metadata is incorrect. (DWR UCIP - omagana) FIELD_STRUCT_DESC: 8-inch steel drainage pipe measured (instead of 10-inch) sleeved through a 12-inch steel pipe, 6.6 feet below the crown. Annular gap grouted at both ends. Active centrifugal pump on platform at landside (LS) toe. Inactive slant pump on steel platform on waterside (WS) slope (not present in 2008 referenced in USACE O&M manual). Exposed section pipe on WS slope. Service pole on the LS slope. (10-inch pipe sleeved through pre-existing 12-pipe under Permit No. 3382, 1960 - Davis J. Eliot and Son; 12-inch pipe authorized in under Permit No. 951, 1944 - Stillwater Orgards Company). [Additional Reference(s): DWR Levee Log, 2005. USACE San Joaquin O&M Manual Unit No. 110, May 1959, (HLM 0.5), 12-inch pipe]. FS Date: 8/17/2016

View of pipe on WS with rip rap on toe--dense vegetation on slope.

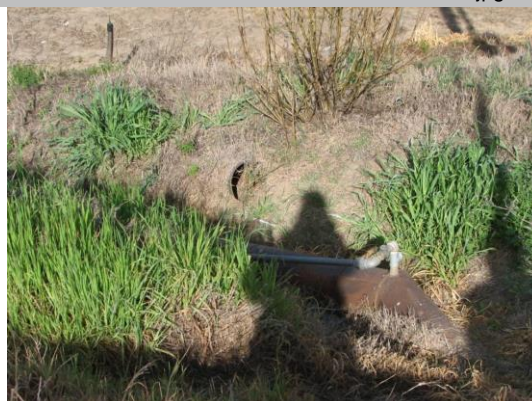
Photo 2 of 3 : UCIP\_FA\_2019\_50062\_36546.jpg

View of pipe on LS--open cut section.

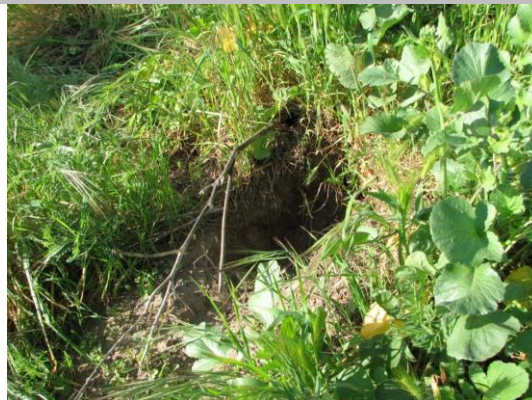
Photo 3 of 3 : UCIP\_FA\_2019\_50062\_36548.jpg

Dense burrow activity--10 inch hole present.

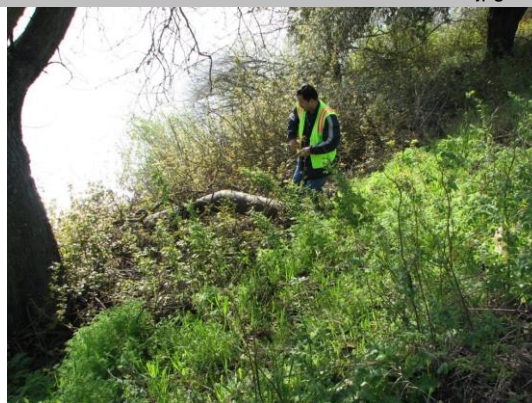
Photo 1 of 3 : UCIP\_FA\_2019\_21572\_36576.jpg

Comment Code					
Inspector Comment					
DS_ID:24521 FS_ID:21572 EP_NO: N/A Repair Type: Non-Urgent Crossing Status: Found UCIP Comments: No records were found during intial desk study--need to contact owner to obtain permit number authorizing work. If crossing is no longer used by owner, the owner will need to coordinate with DWR Inspector and CVFPB to remove crossing according to Title 23 requirements. Dense vegetation limits the inspector's visibility to identify signs of pipe failure (leaks) along the slope. Recommend removing vegetation along pipe alignment to conduct proper inspection of structure and appurtenances. Note date on photos should be 3/18/09 not 7/26/08 camera metadata is incorrect. FIELD_STRUCT_DESC: *ABANDONED* 8-inch irrigation pipe of unknown material through the levee, 13.9 feet below the levee crown. Pump on platform at landside (LS) toe. Service pole on LS slope. FS Date: 3/18/2009

View of pipe crossing located on waterward side--dense vegetation on levee slope.

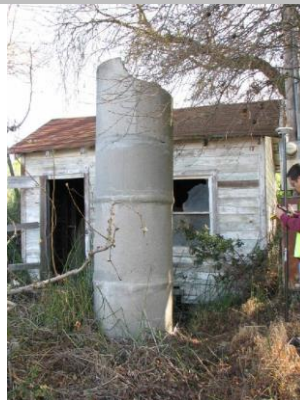
Photo 3 of 3 : UCIP\_FA\_2019\_21572\_36578.jpg

View of pump house, concrete stand pipe, and utility pole.

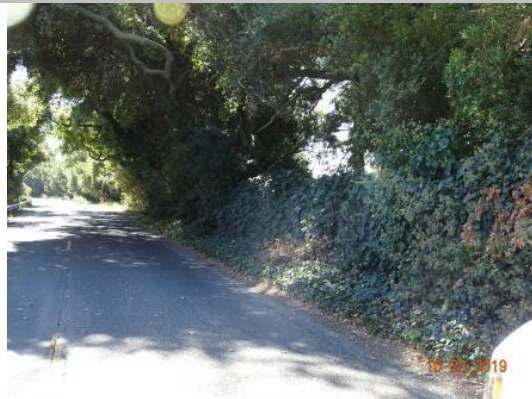
Photo 1 of 1 : FA\_2019\_RD0349\_204\_27\_20191025\_00033.jpg

LM Start	0.98	Rating **	U	Issue No.	27
LM End	1.10	Issue Type +	En	Location *	LS
Category	Earthen Levee			GPS Latitude/Longitude	
				Start	End
Item	Vegetation			38.313200 °	38.311493 °
				-121.578797 °	-121.578257 °
DWR ID	DWR_RD0349_01_f_2017_27				
Comment Code					
V6 : Landscaping					
Inspector Comment					
Landside landscaping must be removed or trimmed to allow inspection and access.

View looking downstream at landscaping on the landside slope (Fall 2019).

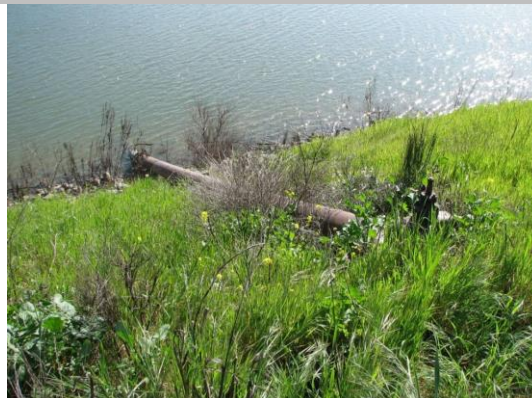
Photo 1 of 3 : UCIP\_FA\_2019\_50013\_36561.jpg

DS\_ID:24140  
FS\_ID:50013  
EP\_NO: N/A  
Repair Type: Non-Urgent  
Crossing Status: Found  
UCIP Comments: 8/22/2016 Crossing has been downgraded from Urgent to Non-Urgent no signs of pipe failure were visible during site inspection. Minor erosion visible on LS shoulder covered by dry leaves. No permit was found--need to contact owner to determine age of crossing and determine when the last internal inspection was completed. (DWR UCIP - omagana)8/13/2009 Exposed section of levee slope on LS--need to contact owner and DWR inspector. Dense vegetation limits the inspector's visibility to identify signs of pipe failure (leaks) along the slope. Recommend removing vegetation along pipe alignment to conduct proper inspection of structure and appurtenances. Note date on photos should be 3/18/09 not 7/26/08 camera metadata is incorrect. (DWR UCIP - omagana)  
FIELD\_STRUCT\_DESC: 14-inch steel irrigation pipe (waterside (WS) shoulder) and 12-inch pipe (landside (LS) shoulder) through the levee, 4.7 feet below the levee crown. Gate valve on the WS slope. Pump in pump house on LS slope. Pressure breaker behind pump house. Pipe exposed on WS slope. [Additional Reference(s): DWR Levee Log, 2005. USACE San Joaquin O&M Manual Unit No. 110, May 1959, HLM 1.1, 14-inch pipe with pump on WS]

View of pipe on WS.

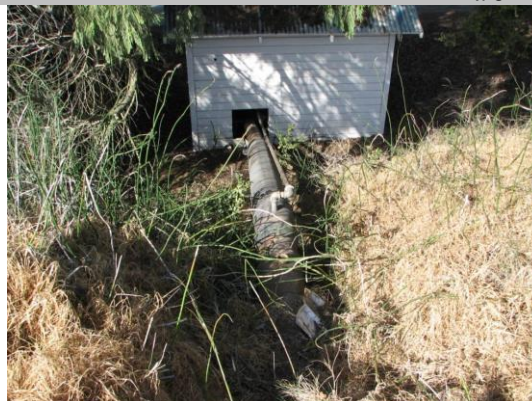
Photo 2 of 3 : UCIP\_FA\_2019\_50013\_36558.jpg

View of LS slope--open cut.

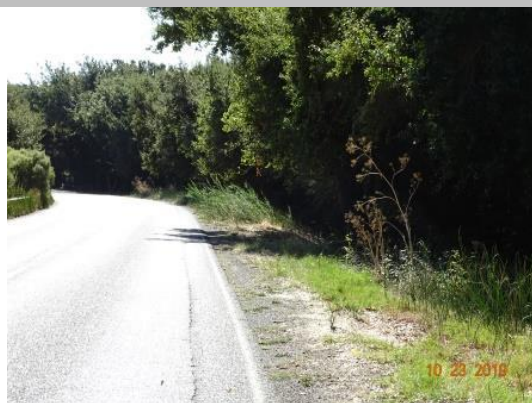
Photo 1 of 1 : FA\_2019\_RD0349\_204\_25\_20191025\_00034.jpg

LM Start	1.15	Rating **	U	Issue No.	25
LM End	1.20	Issue Type +	Ma	Location *	LS
Category	Earthen Levee			GPS Latitude/Longitude	
				Start	End
Item	Vegetation			38.310785 °	38.310123 °
				-121.577963 °	-121.577590 °
DWR ID	DWR_RD0349_01_f_2019_25				
Comment Code					
V2 : Remove the wild growth other than native grasses from the levee slopes.					
Inspector Comment

View looking downstream at vegetation on the landside slope (Fall 2019).

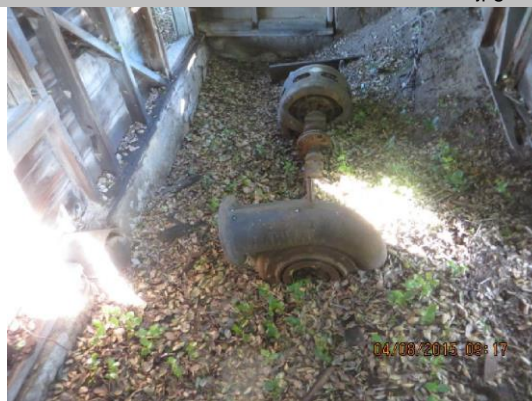
Photo 3 of 3 : UCIP\_FA\_2019\_44304\_73680.jpg

Comment Code						
Inspector Comment						
DS_ID:24141						
FS_ID:44304						
EP_NO: N/A						
Repair Type: Non-Urgent						
Crossing Status: Found						
UCIP Comments: 2007 DWR erosion repair site location?--need to find out fate of crossing. Dense vegetation limits the inspector's visibility to identify signs of pipe failure (leaks) along the slope. Recommend removing vegetation along pipe alignment to conduct proper inspection of structure and appurtenances. Note date on photos should be 3/18/09 not 7/26/08 camera metadata is incorrect.						
FIELD_STRUCT_DESC: *ABANDONED* Pump house located on landside (LS) toe. Pressure breaker on LS. Electromagnetic Survey indicates a crossing at this location. [Additional Reference(s): DWR Levee Log, 2005]						
FS Date: 4/2/2015

Pump and motor inside pumphouse at LS toe. No pipe visible.

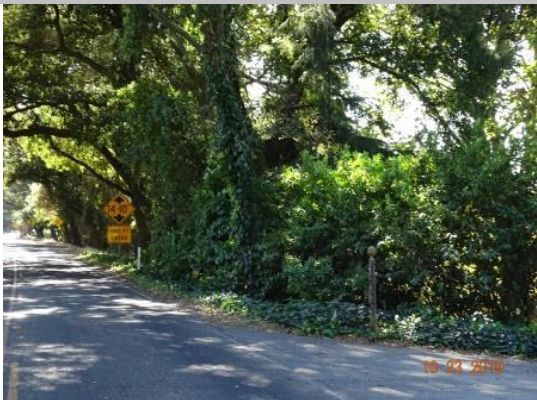
Photo 1 of 1 : FA\_2019\_RD0349\_204\_10\_20191025\_00035.jpg

View looking downstream at landscaping on the landside slope (Fall 2019).

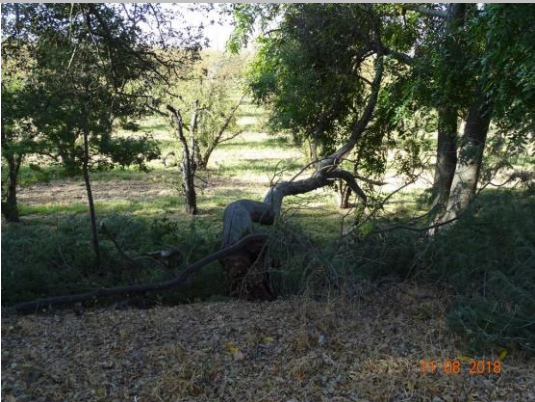
Photo 1 of 1 : FA\_2019\_RD0349\_204\_36\_20190826\_00012.jpg

View of fallen tree limb on the landside toe (November 2018).

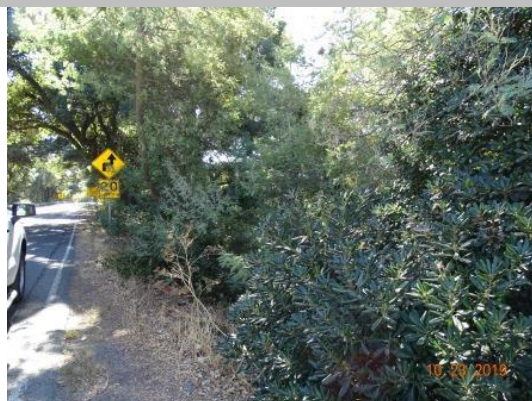
Photo 1 of 1 : FA\_2019\_RD0349\_204\_33\_20191025\_00036.jpg

LM Start	1.45	Rating **	M	Issue No.	33
LM End	1.45	Issue Type +	En	Location *	LS
Category	Earthen Levee			GPS Latitude/Longitude	
				Start	End
Item	Vegetation			38.306919 °	38.306919 °
				-121.575473 °	-121.575473 °
DWR ID	DWR_RD0349_01_f_2017_33				
Comment Code					
V6 : Landscaping					
Inspector Comment					
Landside landscaping should be thinned and maintained to allow inspection and access to levee slope and toe.

View looking downstream at landscaping on the landside slope (Fall 2019).

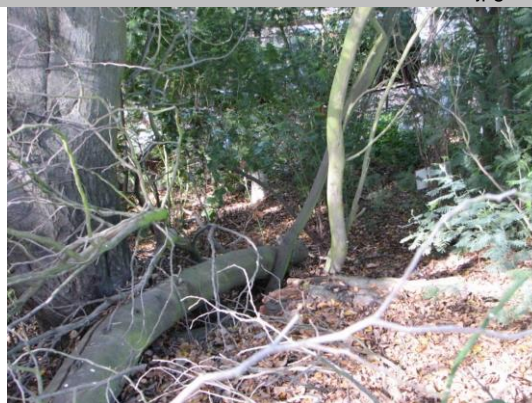
Photo 1 of 3 : UCIP\_FA\_2019\_44214\_36572.jpg

Comment Code						
Inspector Comment						
DS_ID:24143 FS_ID:44214 EP_NO: 12005 Repair Type: Non-Urgent Crossing Status: Found UCIP Comments: Pipe open on WS slope. 2007 Erosion Repair Site location?--Need to contact owner to determine if crossing is still in use. Dense vegetation limits the inspector's visibility to identify signs of pipe failure (leaks) along the slope. Recommend removing vegetation along pipe alignment to conduct proper inspection of structure and appurtenances. Note date on photos should be 3/18/09 not 7/26/08 camera metadata is incorrect. FIELD_STRUCT_DESC: 6-inch steel irrigation pipe through the levee, 4.0 feet below the levee crown. Siphon breaker and protective housing at levee shoulder. Pump located on waterside (WS). Pipe exposed on WS slope, extending to pump. Discharge structure at landside (LS) toe. (pump installed with a 6-inch pipe authorized under Permit No. 12005, 1977 - C. Van Loben Sels) [Additional Reference(s): DWR Levee Log, 2005] FS Date: 4/2/2015

View of landward side.

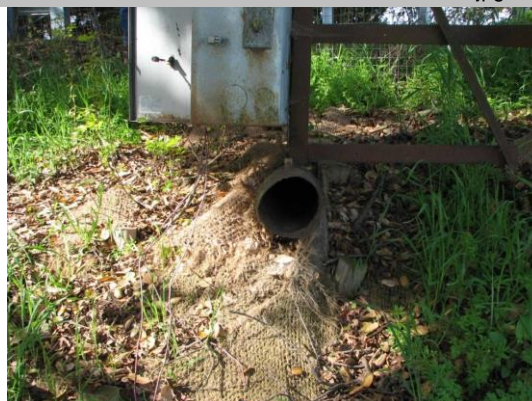
Photo 3 of 3 : UCIP\_FA\_2019\_44214\_36570.jpg

View of pipe at waterward shoulder with control box.

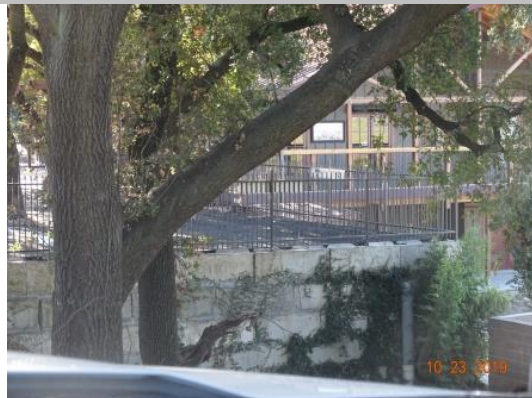
Photo 1 of 1 : FA\_2019\_RD0349\_204\_12\_20191025\_00037.jpg

LM Start	1.54	Rating **	U	Issue No.	12
LM End	1.54	Issue Type +	En	Location *	LS
Category	Earthen Levee			GPS Latitude/Longitude	
				Start	End
Item	Encroachments			38.305722°	38.305722°
				-121.574680°	-121.574695°
DWR ID	DWR_RD0349_01_f_2014_12				
Comment Code					
RW : Retaining Wall					
Inspector Comment					
This issue is under review with the CVFPB. No change.

View of unauthorized retaining wall on the landside (Fall 2019).

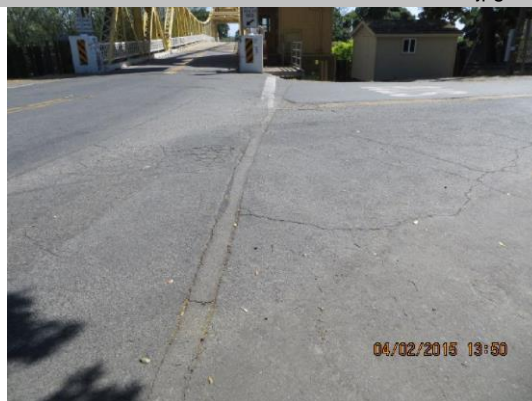
Photo 1 of 3 : UCIP\_FA\_2019\_46168\_74542.jpg

Cut in pavement good indicator of pipe location.

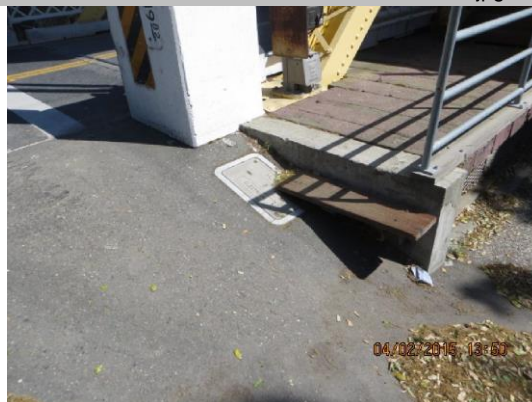
Photo 2 of 3 : UCIP\_FA\_2019\_46168\_74543.jpg

Christy box on WS shoulder.

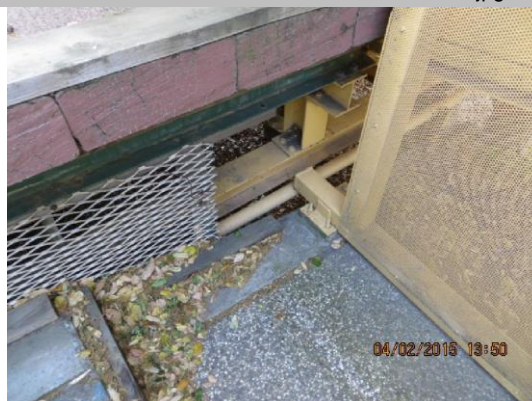
Photo 3 of 3 : UCIP\_FA\_2019\_46168\_74544.jpg

LM Start	0.00	Rating **	M	Issue No.	112 (cont)	
LM End	0.00	Issue Type +	En	Location *		
Category	Supplemental			GPS Latitude/Longitude		
				Start	End	
Item	DRAFT DWR UCIP Field Study			38.305124°	38.305124°	
				-121.574772°	-121.574772°	
DWR ID	25096					
Comment Code						
Inspector Comment						
DS_ID:25096						
FS_ID:46168						
EP_NO: N/A						
Repair Type: Non-Urgent						
Crossing Status: Indicator Found						
UCIP Comments: Need to identify permit for crossing.						
FIELD_STRUCT_DESC: 2-inch waterline through the levee at an unknown depth below crown. Pipe provides service to bridge and beach (per landowner).						
FS Date: 4/9/2015

Pipe visible next to bridge on WS shoulder.

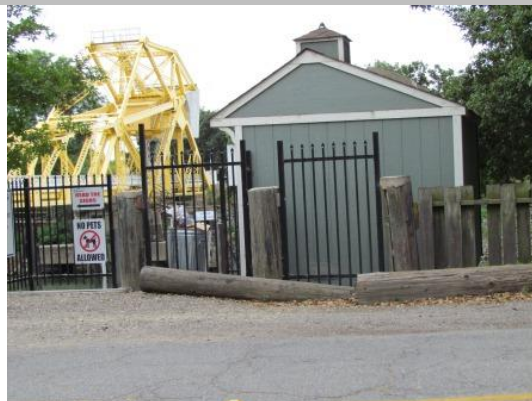
Photo 1 of 2 : FA\_2019\_RD0349\_205\_4\_20190826\_00004.jpg

LM Start	0.01	Rating **	U	Issue No.	4
LM End	0.01	Issue Type +	En	Location *	WS
Category	Earthen Levee			GPS Latitude/Longitude	
				Start	End
Item	Encroachments			38.304870 °	38.304870 °
				-121.574730 °	-121.574730 °
DWR ID	DWR_RD0349_02_s_2012_4				
Comment Code					
BU : Building					
Inspector Comment					
This encroachment is along the waterward shoulder and was not authorized by the CVFPB. There are multiple encroachments at this site. Owner was working with CVFPB to get permits as of 11-2013. This issue is still pending as of 2016. No change. 5-2017.

Unauthorized building waterside shoulder; Unit 2 Sutter Slough.

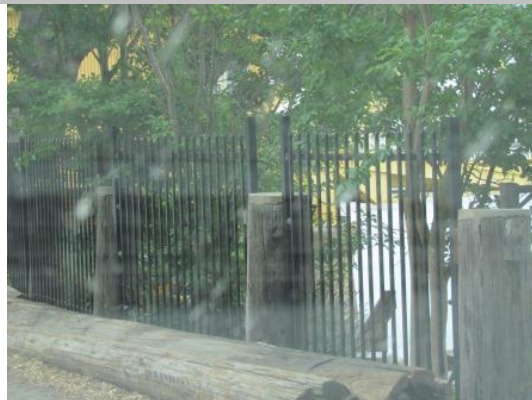
Photo 2 of 2 : FA\_2019\_RD0349\_205\_4\_20190826\_00005.jpg

LM Start	0.01	Rating **	U	Issue No.	4 (cont)	
LM End	0.01	Issue Type +	En	Location *	WS	
Category	Earthen Levee			GPS Latitude/Longitude		
				Start	End	
Item	Encroachments			38.304870 °	38.304870 °	
				-121.574730 °	-121.574730 °	
DWR ID	DWR_RD0349_02_s_2012_4					
Comment Code						
BU : Building						
Inspector Comment						
This encroachment is along the waterward shoulder and was not authorized by the CVFPB. There are multiple encroachments at this site. Owner was working with CVFPB to get permits as of 11-2013. This issue is still pending as of 2016. No change. 5-2017.

Unauthorized fence adjacent to building waterside Sutter Slough.

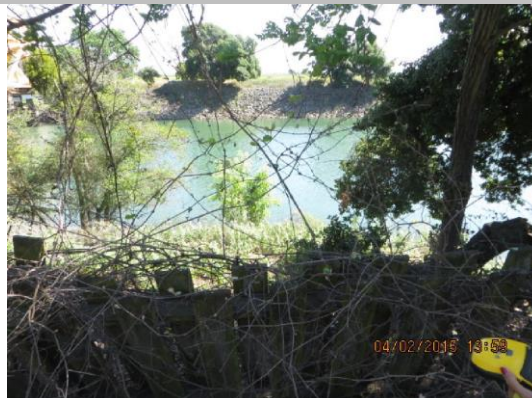
Photo 2 of 3 : UCIP\_FA\_2019\_46169\_74546.jpg

LM Start	0.04	Rating **	M	Issue No.	113 (cont)	
LM End	0.04	Issue Type +	En	Location *		
Category	Supplemental			GPS Latitude/Longitude		
				Start	End	
Item	DRAFT DWR UCIP Field Study			38.304885 °	38.304885 °	
				-121.575369 °	-121.575369 °	
DWR ID	25098					
Comment Code						
Inspector Comment						
DS_ID:25098						
FS_ID:46169						
EP_NO: N/A						
Repair Type: Non-Urgent						
Crossing Status: Found						
UCIP Comments: Appears abandoned and if so should be done so properly. Need to identify permit.						
FIELD_STRUCT_DESC: 1-inch waterline of unknown material through the levee, 1.5-feet below the levee crown. Pipe visible at fence on waterside (WS) slope.						
FS Date: 4/9/2015

Fence on WS shoulder.

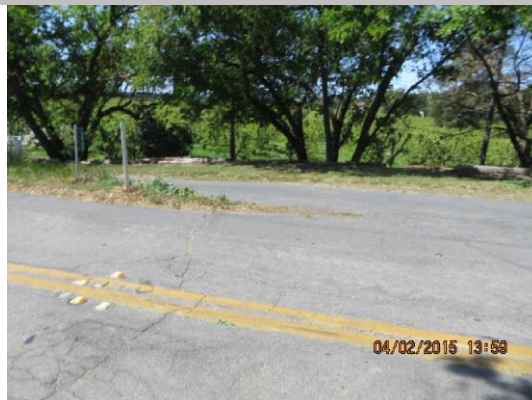
Photo 3 of 3 : UCIP\_FA\_2019\_46169\_74547.jpg

Approximate location of pipe alignment on LS of crown.

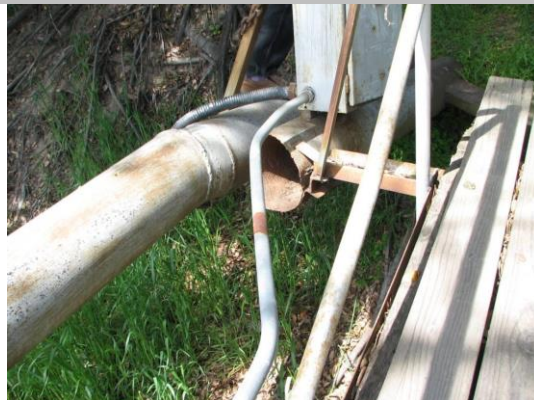
Photo 2 of 3 : UCIP\_FA\_2019\_21576\_36592.jpg

Comment Code						
Inspector Comment						
DS_ID:24145 FS_ID:21576 EP_NO: N/A Repair Type: Non-Urgent Crossing Status: Found UCIP Comments: No connection present--need to contact owner to determine if owner plans to use. If crossing is no longer in use owner will need to coordinate with DWR inspector and CVFPB to remove according to Title 23 requirements. Dense vegetation limits the inspector's visibility to identify signs of pipe failure (leaks) along the slope. Recommend removing vegetation along pipe alignment to conduct proper inspection of structure and appurtenances. Unable to determine if crossing is in use. Note date on photos should be 3/18/09 not 7/26/08 camera metadata is incorrect. FIELD_STRUCT_DESC: *ABANDONED* 10-inch irrigation pipe through the levee, 6.0 feet below the levee crown. Pump and slide gate are located on the waterside (WS) slope. Concrete pipe riser and distribution box located on the landside (LS) toe. Service pole and anchor on the LS slope. [Additional Reference(s): DWR Levee Log, 2005] FS Date: 3/18/2009

Pipes through levee at waterward slope.

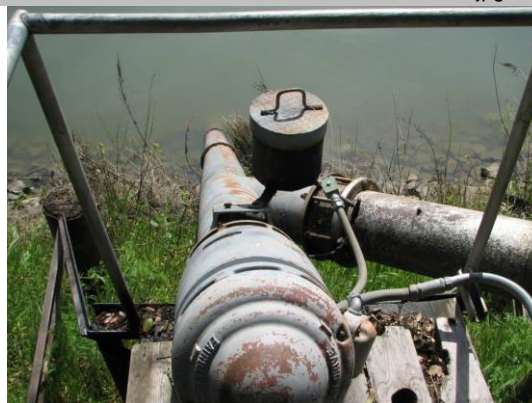
Photo 2 of 3 : UCIP\_FA\_2019\_21577\_36596.jpg

Comment Code						
Inspector Comment						
DS_ID:24146 FS_ID:21577 EP_NO: 2480 Repair Type: Non-Urgent Crossing Status: Found UCIP Comments: Dense vegetation limits the inspector's visibility to identify signs of pipe failure (leaks) along the landward slope. Recommend removing vegetation along pipe alignment to conduct proper inspection of structure and appurtenances. Unable to determine if crossing is in use. Note date on photos should be 3/18/09 not 7/26/08 camera metadata is incorrect. FIELD_STRUCT_DESC: 10-inch steel irrigation pipe through the levee, 6.0 feet below the levee crown. Pump and slide gate on the waterside (WS) slope. Concrete pipe riser and distribution box with gate valve located on the landside (LS) toe. Service pole and anchor on the LS slope. (10-inch pipe installed under Permit No. 2480, 1959 - L. C. Peck) [Additional Reference(s): DWR Levee Log, 2005] FS Date: 3/18/2009

View of waterward side--pump and raised platform.

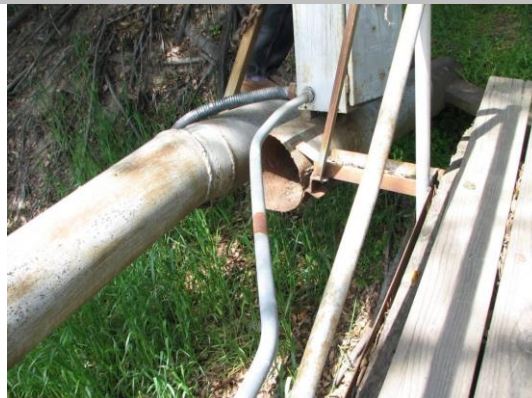
Photo 3 of 3 : UCIP\_FA\_2019\_21577\_36598.jpg

Comment Code						
Inspector Comment						
DS_ID:24146 FS_ID:21577 EP_NO: 2480 Repair Type: Non-Urgent Crossing Status: Found UCIP Comments: Dense vegetation limits the inspector's visibility to identify signs of pipe failure (leaks) along the landward slope. Recommend removing vegetation along pipe alignment to conduct proper inspection of structure and appurtenances. Unable to determine if crossing is in use. Note date on photos should be 3/18/09 not 7/26/08 camera metadata is incorrect. FIELD_STRUCT_DESC: 10-inch steel irrigation pipe through the levee, 6.0 feet below the levee crown. Pump and slide gate on the waterside (WS) slope. Concrete pipe riser and distribution box with gate valve located on the landside (LS) toe. Service pole and anchor on the LS slope. (10-inch pipe installed under Permit No. 2480, 1959 - L. C. Peck) [Additional Reference(s): DWR Levee Log, 2005] FS Date: 3/18/2009

Pipes through levee at waterward slope.

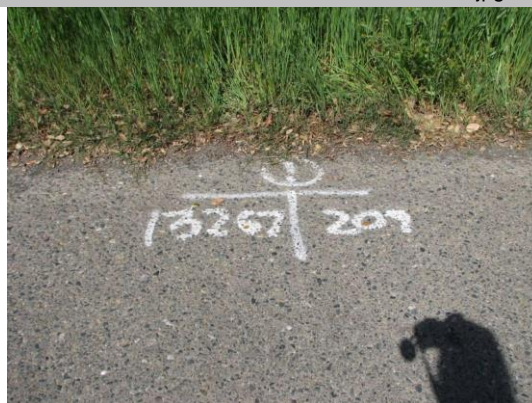
Photo 1 of 3 : UCIP\_FA\_2019\_21613\_36685.jpg

Item	DRAFT DWR UCIP Field Study		38.304345°	38.304345°	
			-121.576824°	-121.576824°	
DWR ID	24147				
Comment Code					
Inspector Comment					
DS_ID:24147 FS_ID:21613 EP_NO: N/A Repair Type: Non-Urgent Crossing Status: Found UCIP Comments: Dense vegetation limits the inspector's visibility to identify signs of pipe failure (leaks) along the slope. Recommend removing vegetation along pipe alignment to conduct proper inspection of structure and appurtenances. Note date on photos should be 3/18/09 not 7/26/08 camera metadata is incorrect. FIELD_STRUCT_DESC: 3-inch steel siphon irrigation pipe through the levee, 3.3 feet below the levee crown. Gate valve on landside (LS). [Additional Reference(s): DWR Levee Log, 2005. USACE Sacramento O&M Manual Unit No. 110, May 1959, revised 29 Dec 2016, (HLM 0.1)] FS Date: 3/18/2009

Underground service alert (USA) marking on levee crown.

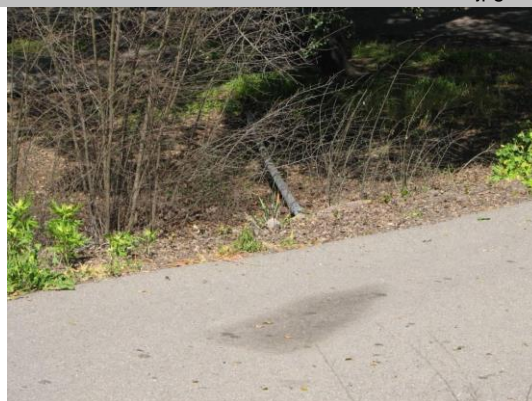
Photo 2 of 3 : UCIP\_FA\_2019\_21613\_36687.jpg

Comment Code						
Inspector Comment						
DS_ID:24147						
FS_ID:21613						
EP_NO: N/A						
Repair Type: Non-Urgent						
Crossing Status: Found						
UCIP Comments: Dense vegetation limits the inspector's visibility to identify signs of pipe failure (leaks) along the slope. Recommend removing vegetation along pipe alignment to conduct proper inspection of structure and appurtenances. Note date on photos should be 3/18/09 not 7/26/08 camera metadata is incorrect.						
FIELD_STRUCT_DESC: 3-inch steel siphon irrigation pipe through the levee, 3.3 feet below the levee crown. Gate valve on landside (LS).						
[Additional Reference(s): DWR Levee Log, 2005. USACE Sacramento O&M Manual Unit No. 110, May 1959, revised 29 Dec 2016, (HLM 0.1)]						
FS Date: 3/18/2009

View of crossing on landward side.

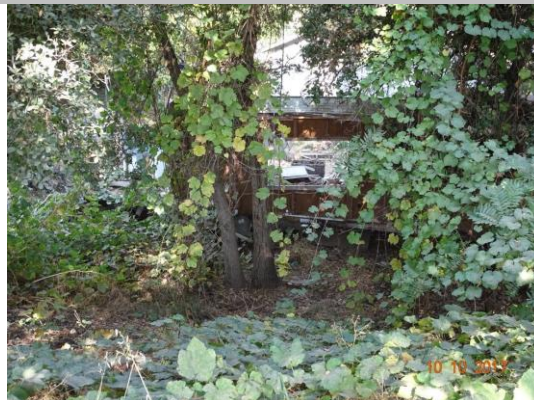
Photo 1 of 1 : FA\_2019\_RD0349\_205\_73\_20190826\_00050.jpg

Material/debris on landside slope.

LM Start	0.16	Rating **	M	Issue No.	73
LM End	0.16	Issue Type +	En	Location *	LS
Category	Earthen Levee			GPS Latitude/Longitude	
				Start	End
Item	Encroachments			38.304117°	38.304117°
				-121.577263°	-121.577263°
DWR ID	DWR_RD0349_02_s_2014_73				
Comment Code					
MA : Material					
Inspector Comment					
Remove the material from the landside levee section.

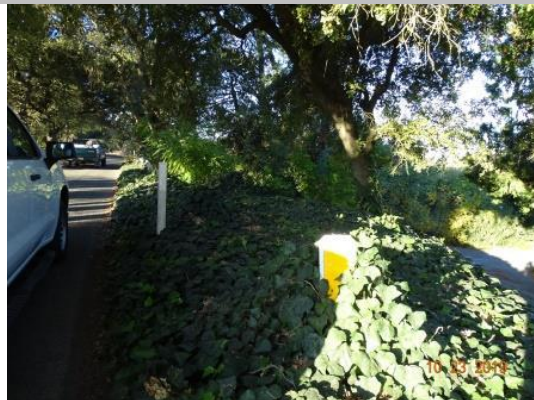
Photo 1 of 1 : FA\_2019\_RD0349\_205\_76\_20191025\_00119.jpg

LM Start	0.22	Rating **	U	Issue No.	76
LM End	0.22	Issue Type +	En	Location *	LS
Category	Earthen Levee			GPS Latitude/Longitude	
				Start	End
Item	Vegetation			38.303528 °	38.303528 °
				-121.578179 °	-121.578179 °
DWR ID	DWR_RD0349_02_s_2018_76				
Comment Code					
V6 : Landscaping					
Inspector Comment					
Thick ivy prevents inspection and access. Should be removed.

View looking downstream at ivy on the landside slope (Fall 2019).

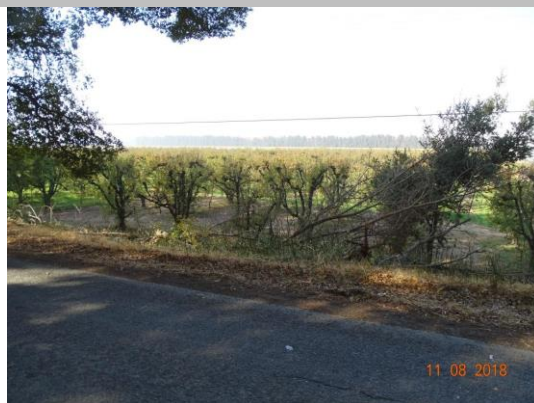
Photo 1 of 1 : FA\_2019\_RD0349\_205\_75\_20190826\_00051.jpg

View of downed tree on the landside slope (November 2018).

LM Start	0.25	Rating **	M	Issue No.	75
LM End	0.25	Issue Type +	Ma	Location *	LS
Category	Earthen Levee			GPS Latitude/Longitude	
				Start	End
Item	Encroachments			38.303317 °	38.303317 °
				-121.578673 °	-121.578673 °
DWR ID	DWR_RD0349_02_f _ 2018_75				
Comment Code					
TR : Tree or limb					
Inspector Comment					
Remove downed tree from the landside slope.

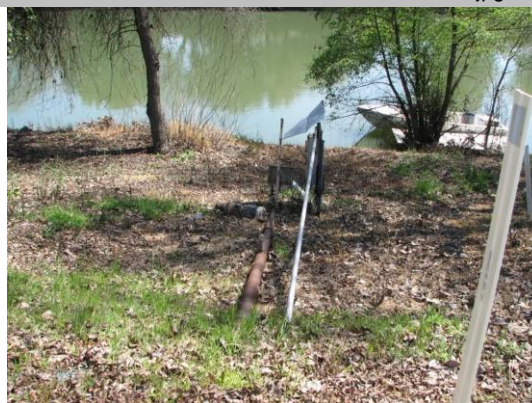
Photo 1 of 3 : UCIP\_FA\_2019\_21615\_36694.jpg

Comment Code					
Inspector Comment					
DS_ID:24149 FS_ID:21615 EP_NO: N/A Repair Type: Non-Urgent Crossing Status: Found UCIP Comments: Need to contact owner (Permit No. 3678) to determine if crossing is still in use. If crossing is not in use will need to coordinate with DWR Inspector and CVFPB to remove pipe according to Title 23 requirements. Note date on photos should be 3/18/09 not 7/26/08 camera metadata is incorrect. FIELD_STRUCT_DESC: 6-inch steel irrigation pipe through the levee, 2.5 feet below the crown. Pump on waterside (WS) slope. Service pole at landside (LS) shoulder. 3-inch conduit through levee to service pump. (removed and installed pump, and construction of cement filled steel piling foundation on levee authorized under Permit No. 3678, 1961 - Ostman Bros.) [Additional Reference(s): DWR Levee Log, 2005. USACE Sacramento O&M Manual Unit No. 110, May 1959, revised 29 Dec 2016, (HLM 0.6)] FS Date: 3/18/2009

View of pipe and pump on waterward side.

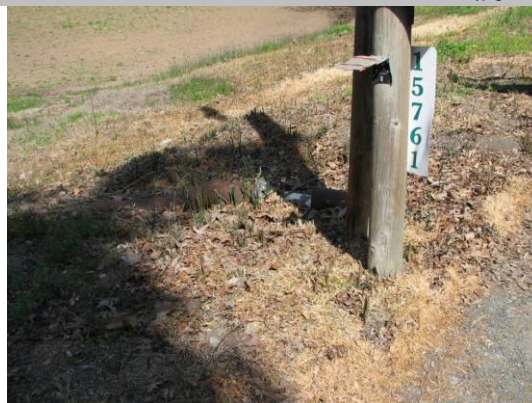
Photo 2 of 3 : UCIP\_FA\_2019\_21615\_36695.jpg

View of landard shoulder--service pole and pipe section through slope.

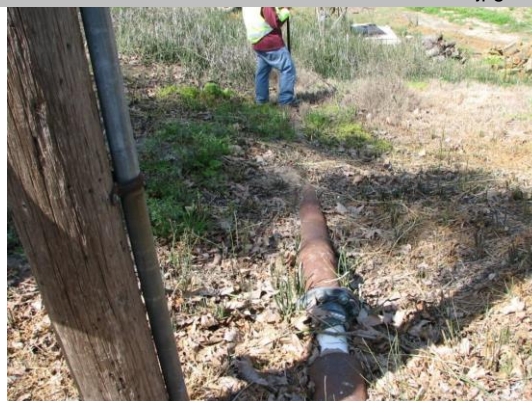
Photo 3 of 3 : UCIP\_FA\_2019\_21615\_36696.jpg

Comment Code						
Inspector Comment						
DS_ID:24149 FS_ID:21615 EP_NO: N/A Repair Type: Non-Urgent Crossing Status: Found UCIP Comments: Need to contact owner (Permit No. 3678) to determine if crossing is still in use. If crossing is not in use will need to coordinate with DWR Inspector and CVFPB to remove pipe according to Title 23 requirements. Note date on photos should be 3/18/09 not 7/26/08 camera metadata is incorrect. FIELD_STRUCT_DESC: 6-inch steel irrigation pipe through the levee, 2.5 feet below the crown. Pump on waterside (WS) slope. Service pole at landside (LS) shoulder. 3-inch conduit through levee to service pump. (removed and installed pump, and construction of cement filled steel piling foundation on levee authorized under Permit No. 3678, 1961 - Ostman Bros.) [Additional Reference(s): DWR Levee Log, 2005. USACE Sacramento O&M Manual Unit No. 110, May 1959, revised 29 Dec 2016, (HLM 0.6)] FS Date: 3/18/2009

View of landward side--it appears PVC pipe was sleeved through existing crossing.

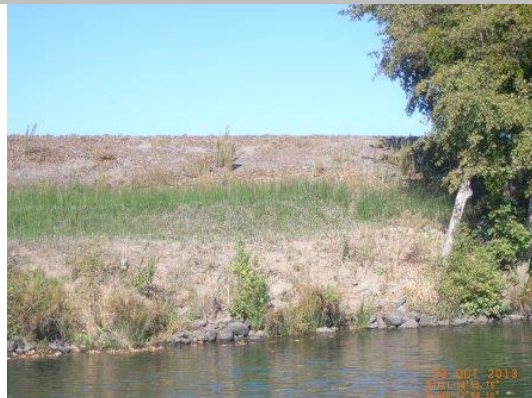
Photo 1 of 1 : FA\_2019\_RD0349\_205\_28\_20190826\_00013.jpg

LM Start	0.60	Rating **	M	Issue No.	28
LM End	0.72	Issue Type +	Ma	Location *	WS
Category	Supplemental			GPS Latitude/Longitude	
				Start	End
Item	2017 USACE Erosion Survey			38.298897 °	38.297384 °
				-121.581571 °	-121.582176 °
DWR ID	DWR_RD0349_02_f_2018_28				
Comment Code					
Inspector Comment					
2017 Site ID: STM 25.5 R					
Status: Eroding					
2017 Field Notes: No observed change.					
Site History: 2010 - Small maintenance, erosion into the toe. 2011 -					
Minor new erosion at toe. 2015 - Minor new erosion at toe, new tree					
pop-out. 2016 - Fresh scarp at downstream end.

USACE 2013 Photo #1

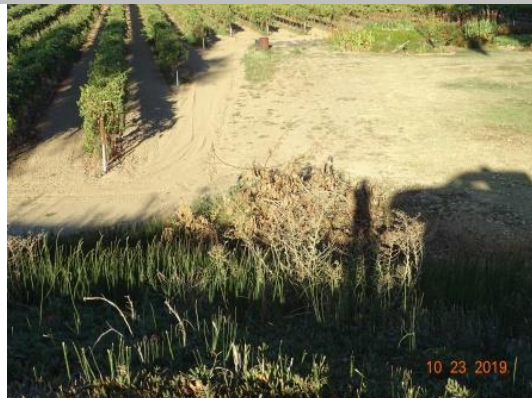
Photo 1 of 1 : FA\_2019\_RD0349\_205\_77\_20191025\_00122.jpg

LM Start	0.60	Rating **	M	Issue No.	77
LM End	0.60	Issue Type +	En	Location *	LS
Category	Earthen Levee			GPS Latitude/Longitude	
				Start	End
Item	Encroachments			38.298987 °	38.298987 °
				-121.581845 °	-121.581845 °
DWR ID	DWR_RD0349_02_f_2019_77				
Comment Code					
TR : Tree or limb					
Inspector Comment

View looking downslope at down branches on the landside slope (Fall 2019).

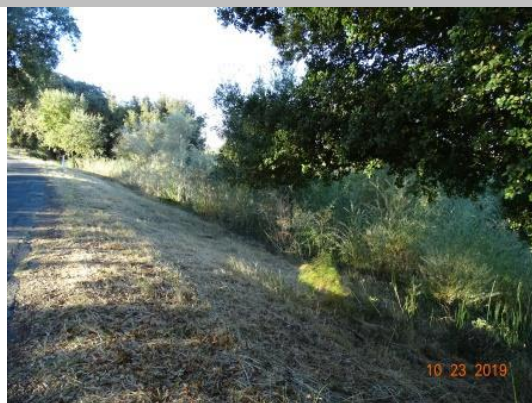
Photo 1 of 1 : FA\_2019\_RD0349\_205\_78\_20191025\_00123.jpg

LM Start	0.68	Rating **	U	Issue No.	78
LM End	0.75	Issue Type +	Ma	Location *	LS
Category	Earthen Levee			GPS Latitude/Longitude	
				Start	End
Item	Vegetation			38.297942°	38.296947°
				-121.582338°	-121.582478°
DWR ID	DWR_RD0349_02_f_2019_78				
Comment Code					
V2 : Remove the wild growth other than native grasses from the levee slopes.					
Inspector Comment

View looking downstream at thick vegetation on the landside slope (Fall 2019).

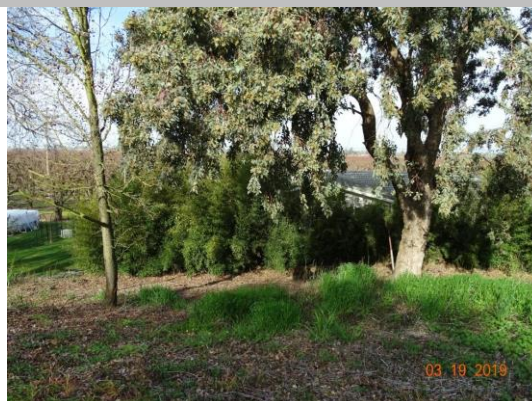
Photo 1 of 1 : FA\_2019\_RD0349\_205\_63\_20190826\_00046.jpg

LM Start	1.00	Rating **	U	Issue No.	63
LM End	1.03	Issue Type +	En	Location *	LS
Category	Earthen Levee			GPS Latitude/Longitude	
				Start	End
Item	Vegetation			38.293467 °	38.292930 °
				-121.583548 °	-121.583702 °
DWR ID	DWR_RD0349_02_s_2019_63				
Comment Code					
V6 : Landscaping					
Inspector Comment					
Landscaping is blocking view of the landside toe

View of landscaping on the landside slope (Spring 2019).

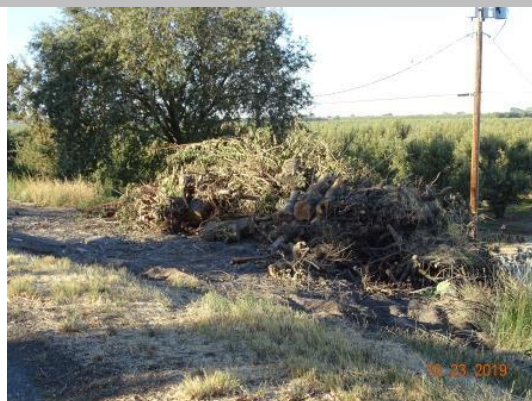
Photo 1 of 1 : FA\_2019\_RD0349\_205\_53\_20191025\_00126.jpg

LM Start	1.06	Rating **	U	Issue No.	53
LM End	1.06	Issue Type +	En	Location *	LS
Category	Earthen Levee			GPS Latitude/Longitude	
				Start	End
Item	Encroachments			38.292599 °	38.292599 °
				-121.583849 °	-121.583849 °
DWR ID	DWR_RD0349_02_s_2018_53				
Comment Code					
PR : Prunings					
Inspector Comment

View of prunings on the landside shoulder (Fall 2019).

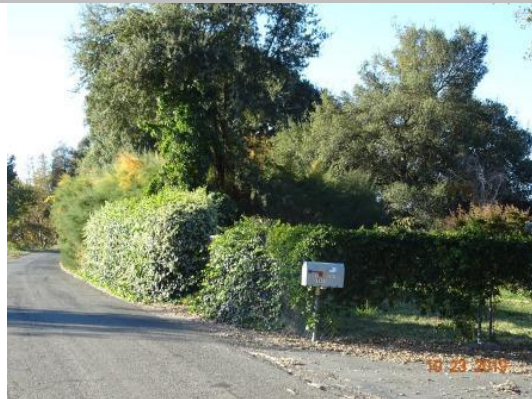
Photo 1 of 1 : FA\_2019\_RD0349\_205\_57\_20191025\_00127.jpg

LM Start	1.31	Rating **	U	Issue No.	57
LM End	1.35	Issue Type +	En	Location *	LS
Category	Earthen Levee			GPS Latitude/Longitude	
				Start	End
Item	Vegetation			38.288963 °	38.288457 °
				-121.584022 °	-121.584035 °
DWR ID	DWR_RD0349_02_f_2017_57				
Comment Code					
V6 : Landscaping					
Inspector Comment					
Landside landscaping should be thinned and maintained to allow inspection and access to levee slope and toe.

View looking downstream at landscaping on the landside shoulder (Fall 2019).

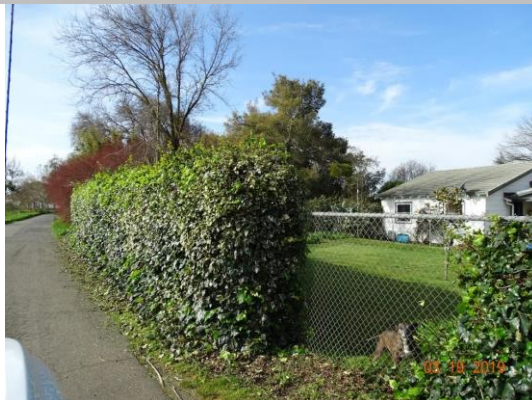
Photo 1 of 1 : FA\_2019\_RD0349\_205\_82\_20190826\_00056.jpg

LM Start	1.31	Rating **	M	Issue No.	82
LM End	1.33	Issue Type +	En	Location *	LS
Category	Earthen Levee			GPS Latitude/Longitude	
				Start	End
Item	Encroachments			38.288917 °	38.288665 °
				-121.584030 °	-121.584022 °
DWR ID	DWR_RD0349_02_s_2019_82				
Comment Code					
FE : Fence					
Inspector Comment					
Chainlink fence is located on the landside shoulder.

View looking downstream at chainlink fence on the landside shoulder (Spring 2019).

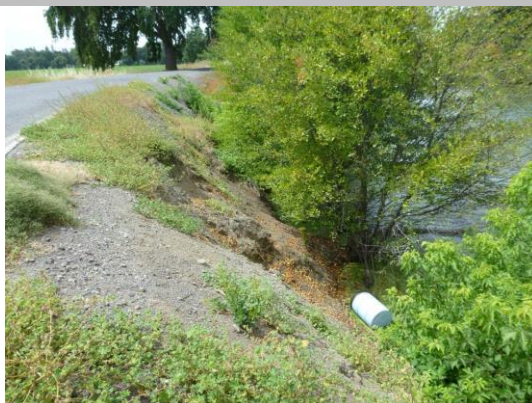
Photo 1 of 3 : FA\_2019\_RD0349\_205\_40\_20190826\_00024.jpg

LM Start	1.33	Rating **	M	Issue No.	40
LM End	1.49	Issue Type +	Ma	Location *	
Category	Supplemental			GPS Latitude/Longitude	
				Start	End
Item	2017 Storm Damage			38.288727 °	38.286475 °
				-121.583823 °	-121.585026 °
DWR ID	DWR_RD0349_02_s_2012_28				
Comment Code					
Inspector Comment					
Levee Evaluation Comments					
Description:					
Site ID No:66					
Site Designation:DWR_RD0349_02_s_2012_28					
Repair Type: Erosion					
Rating:Area of Concern					
Field Date:6/7/2017					
Notes: dense vegetation and large trees hindered visibility; slope riprap appeared failing in some parts

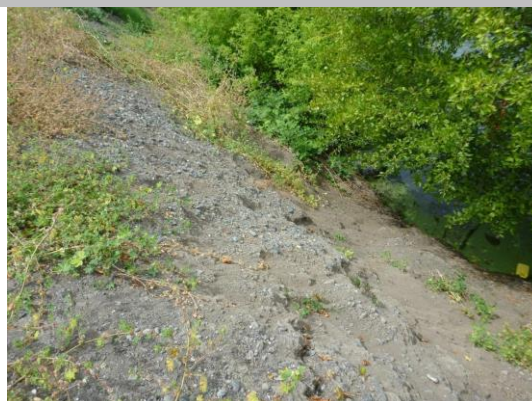
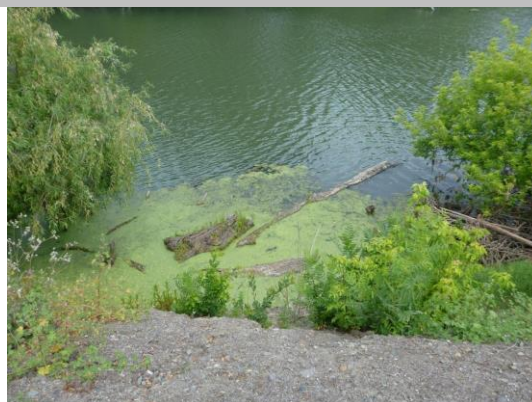
LM Start	1.33	Rating **	M	Issue No.	40 (cont)
LM End	1.49	Issue Type +	Ma	Location *	
Category	Supplemental			GPS Latitude/Longitude	
				Start	End
Item	2017 Storm Damage			38.288727 °	38.286475 °
				-121.583823 °	-121.585026 °
DWR ID	DWR_RD0349_02_s_2012_28				
Comment Code					
Inspector Comment					
Levee Evaluation Comments					
Description:					
Site ID No:66					
Site Designation:DWR_RD0349_02_s_2012_28					
Repair Type: Erosion					
Rating:Area of Concern					
Field Date:6/7/2017					
Notes: dense vegetation and large trees hindered visibility; slope riprap appeared failing in some parts

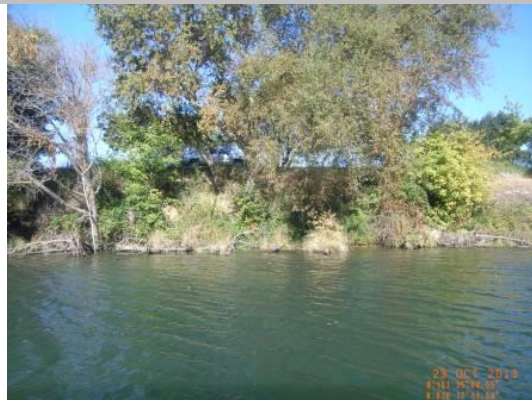
Photo 1 of 1 : FA\_2019\_RD0349\_205\_27\_20190826\_00012.jpg

Comment Code					
Inspector Comment					
2017 Site ID: STM 24.7 R					
Status: Critical					
2017 Field Notes: No observed change.					
Site History: 1997 - Erosion of very sandy levee behind large stand of riparian vegetation on top right bank. Dry ravel of sand. 1999 - Quarry waste rock was dumped down the levee slope; poor repair job; still eroding in places. Eroding at midslope off fabric. 2005 - Length revised, only the middle 150 - 200 ft are eroding. 2006 - Some rock/small material dumped down the bank but it is slowly unraveling. Upstream end is unraveling faster. Steep slope with poor gradation so fines are washing out. 2010 - Lots of overhanging trees and erosion pockets. 2011 - This site is upgraded to CRITICAL. Near vertical bank at the downstream end. New erosion at various locations throughout the site.

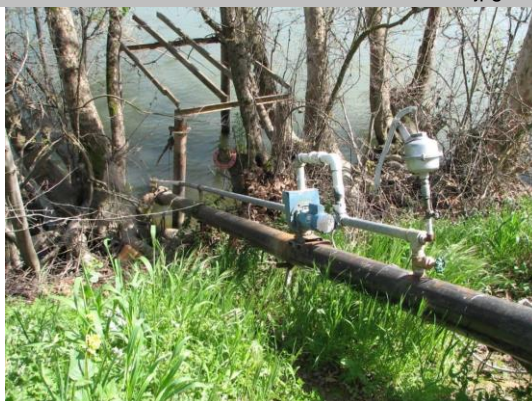
Photo 1 of 3 : UCIP\_FA\_2019\_21606\_36655.jpg

Comment Code						
Inspector Comment						
DS_ID:24154 FS_ID:21606 EP_NO: 6274 Repair Type: Non-Urgent Crossing Status: Found UCIP Comments: Crossing appears to have been altered--recommend coordinating with owner to determine records for crossing. Will need permit issued for pipe install. Dense vegetation limits the inspector's visibility to identify signs of pipe failure (leaks) along the slope. Recommend removing vegetation along pipe alignment to conduct proper inspection of structure and appurtenances. Note date on photos should be 3/18/09 not 7/26/08 camera metadata is incorrect. FIELD_STRUCT_DESC: 12-inch steel irrigation pipe through the levee, 3 feet below the crown. Cutoff wall around pipe at waterside (WS) shoulder. Siphon breaker at landside (LS) shoulder. Air vent and pressure breaker on WS slope. Slant pump on the WS slope. Concrete distribution box at LS toe. (12-inch pipe and slant mounted pump installed and existing 8-inch pipe removed under Permit No. 6274, 1974 - P. L. Peck) [Additional Reference(s): DWR Levee Log, 2005] FS Date: 3/18/2009

View of abandoned framing located on river's edge.

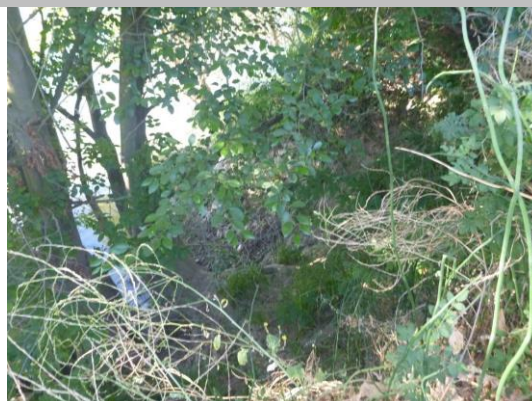
Photo 2 of 2 : FA\_2019\_RD0349\_205\_37\_20190826\_00023.jpg

LM Start	<b>1.48</b>	Rating **	A/W	Issue No.	<b>37 (cont)</b>
LM End	<b>1.49</b>	Issue Type +	Ma	Location *	
Category	Supplemental			GPS Latitude/Longitude	
				Start	End
Item	2017 Storm Damage			38.286708 °	38.286569 °
				-121.584839 °	-121.585042 °
DWR ID	LMA-150				
Comment Code					
Inspector Comment					
<p>Levee Evaluation Comments</p> <p>Description: District Station 78+51 to 79+28, Sec. 18, T. 5 N. R. 4 E., M.D.M. Approximately 77 linear feet of erosion and scour exist along the water side slope of Steamboat Slough (Unit 2). The erosion area commences approximately halfway down the slope from the levee crown and extends to the waterside toe around existing trees. No rip rap is visible in this area.</p> <p>Site ID No: 323</p> <p>Site Designation: LMA-150</p> <p>Repair Type: Erosion</p> <p>Rating: Area of Concern</p> <p>Field Date: 7/28/2017</p> <p>Notes: no berm</p>

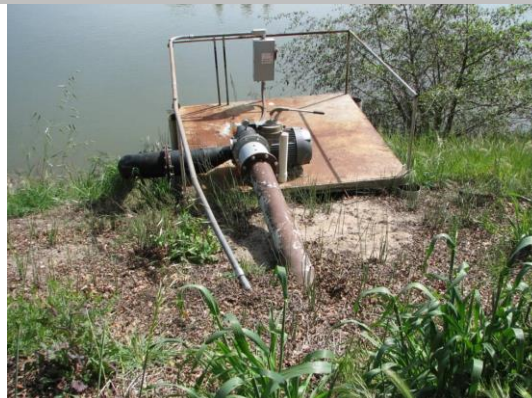
Photo 1 of 3 : UCIP\_FA\_2019\_21607\_36661.jpg

Comment Code					
Inspector Comment					
DS_ID:24155 FS_ID:21607 EP_NO: 1116 Repair Type: Non-Urgent Crossing Status: Found UCIP Comments: Dense vegetation limits the inspector's visibility to identify signs of pipe failure (leaks) along the landward slope. Recommend removing vegetation along pipe alignment to conduct proper inspection of structure and appurtenances. Note date on photos should be 3/18/09 not 7/26/08 camera metadata is incorrect. FIELD_STRUCT_DESC: 8-inch steel irrigation pipe through the levee, 4.7 feet below the levee crown. Two concrete cutoff walls under each shoulder. Pressure breaker in concrete riser at levee shoulder. Pump on waterside (WS). (8-inch pipe atuhorized under Permit No. 1116, 1974 - A. C. Ostman). [Additional Reference(s): DWR Levee Log, 2005. USACE Sacramento O&M Manual Unit No. 110, May 1959, revised 29 Dec 2016, (HLM 1.7)] FS Date: 3/18/2009

View of waterward side.

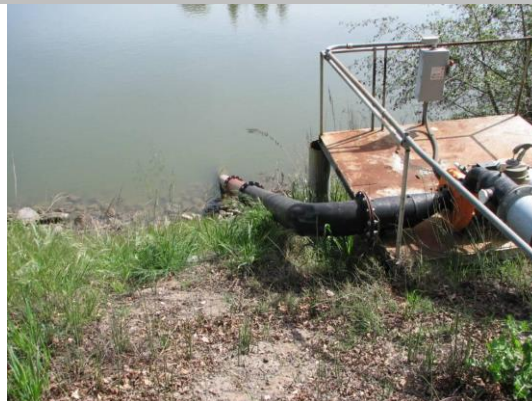
Photo 2 of 3 : UCIP\_FA\_2019\_21607\_36659.jpg

Pipe at the waterward toe.

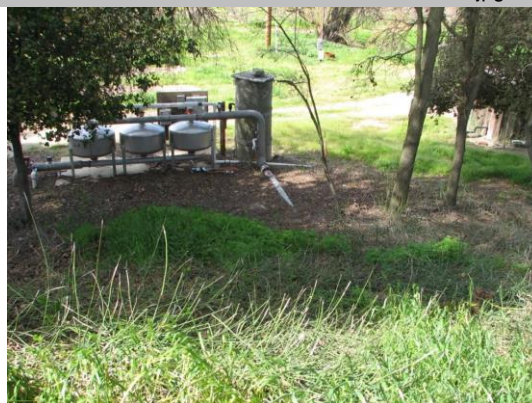
Photo 3 of 3 : UCIP\_FA\_2019\_21607\_36658.jpg

Comment Code						
Inspector Comment						
DS_ID:24155 FS_ID:21607 EP_NO: 1116 Repair Type: Non-Urgent Crossing Status: Found UCIP Comments: Dense vegetation limits the inspector's visibility to identify signs of pipe failure (leaks) along the landward slope. Recommend removing vegetation along pipe alignment to conduct proper inspection of structure and appurtenances. Note date on photos should be 3/18/09 not 7/26/08 camera metadata is incorrect. FIELD_STRUCT_DESC: 8-inch steel irrigation pipe through the levee, 4.7 feet below the levee crown. Two concrete cutoff walls under each shoulder. Pressure breaker in concrete riser at levee shoulder. Pump on waterside (WS). (8-inch pipe atuhorized under Permit No. 1116, 1974 - A. C. Ostman). [Additional Reference(s): DWR Levee Log, 2005. USACE Sacramento O&M Manual Unit No. 110, May 1959, revised 29 Dec 2016, (HLM 1.7)] FS Date: 3/18/2009

Filter system, control panel, and stand pipe located at the landward toe.

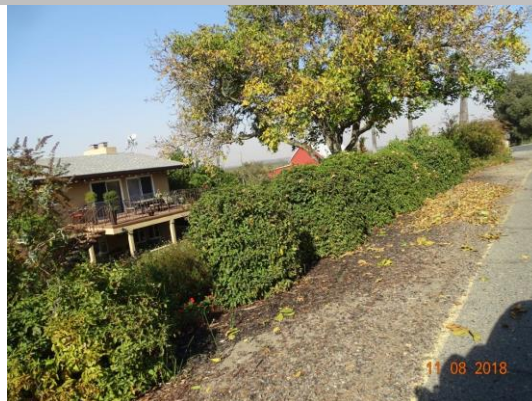
Photo 1 of 1 : FA\_2019\_RD0349\_205\_66\_20190826\_00049.jpg

LM Start	<b>1.75</b>	Rating **	M	Issue No.	<b>66</b>
LM End	<b>1.75</b>	Issue Type +	En	Location *	LS
Category	Earthen Levee		GPS Latitude/Longitude		
			Start	End	
Item	Vegetation		38.284205°	38.284205°	
			-121.588760°	-121.588760°	
DWR ID	DWR_RD0349_02_f_2018_66				
Comment Code					
V6 : Landscaping					
Inspector Comment

View looking downstream at landscaping on the landside shoulder (November 2018).

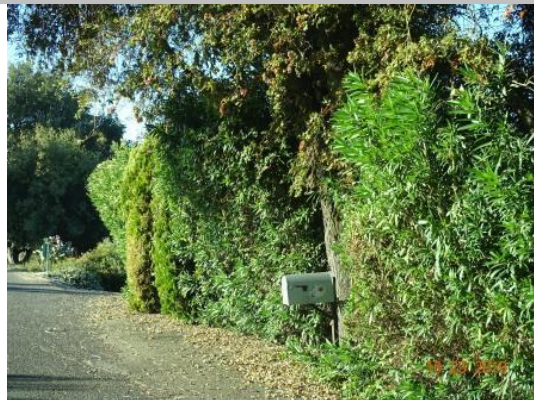
Photo 1 of 1 : FA\_2019\_RD0349\_205\_58\_20191025\_00128.jpg

LM Start	1.80	Rating **	U	Issue No.	58
LM End	1.80	Issue Type +	En	Location *	LS
Category	Earthen Levee			GPS Latitude/Longitude	
				Start	End
Item	Vegetation			38.283642 °	38.283642 °
				-121.589158 °	-121.589158 °
DWR ID	DWR_RD0349_02_f_2017_58				
Comment Code					
V6 : Landscaping					
Inspector Comment					
Landside landscaping should be thinned and maintained to allow inspection and access to levee slope and toe.

View looking downstream at landscaping on the landside shoulder (Fall 2019).
